# 高圧水素ガスシール用ゴムの内部き裂発生メカニズム についての破壊力学的検討

第8回ゴムの力学研究分科会  
平成23年度研究分科会(第1回)～水素高分子材料研究分科会～  
2011年7月15日 九州大学伊都キャンパス

九州大学 水素エネルギー国際研究センター 水素安全学研究部門  
山辺純一郎  
yamabe@mech.kyushu-u.ac.jp

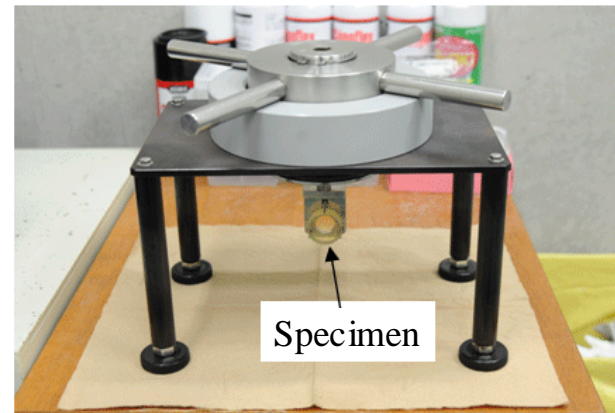
10 MPa hydrogen vessel with glass windows

- Hydrogen vessel with glass windows was employed; then, crack initiation behavior of the rubber during pressurization was also observed.

Camera: SONY  $\alpha$ 900 DSLR-A900, SAL100M28

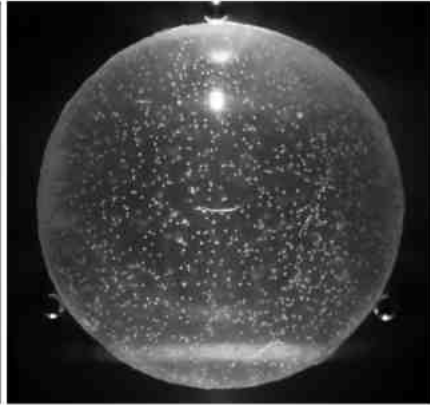
- The specimen was exposed to hydrogen gas at 10 MPa and 25 °C for 65 h.
- No cracks were observed during hydrogen exposure and during decompression.
- Many cracks were observed after decompression, and grew with the elapsed time after decompression.

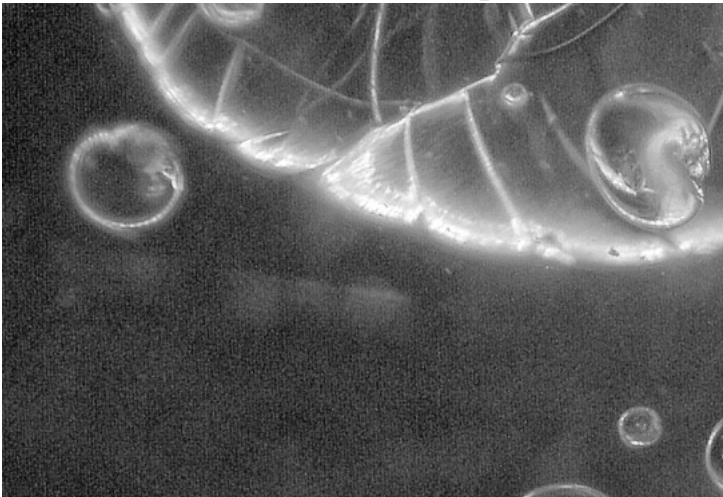
- Micrometer-size cracks initiated from the interior of rubber material.

(a) 20 min after decompression

(b) 21 min after decompression

(c) 26 min after decompression

(d) 27 min after decompression

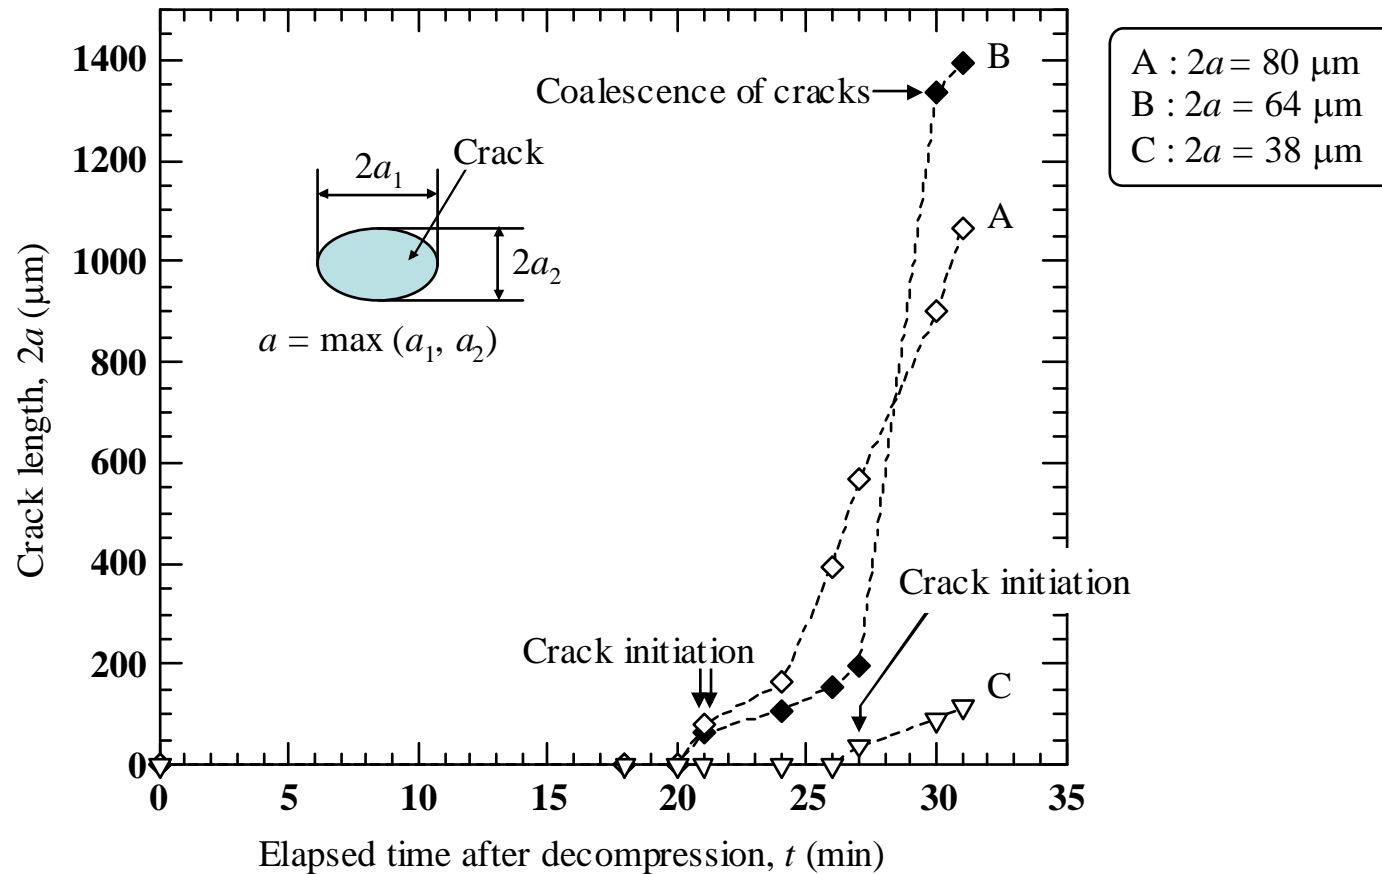
- The cracks grow with the elapsed time after decompression.  
This behavior is related to crack growth under constant loading.  
This type of crack growth is generally referred to as static crack growth.

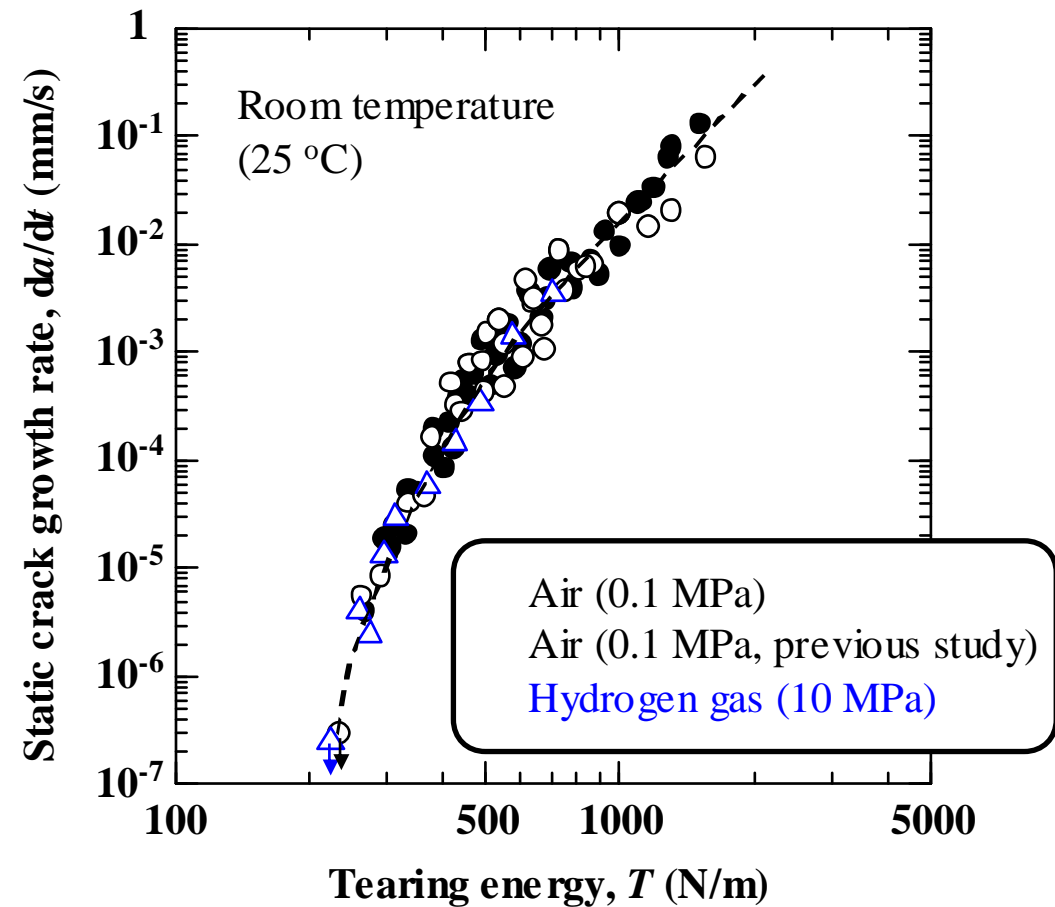
- Constant strain was applied to cut specimen.
- Relationship between static crack growth rate and tearing energy is obtained.

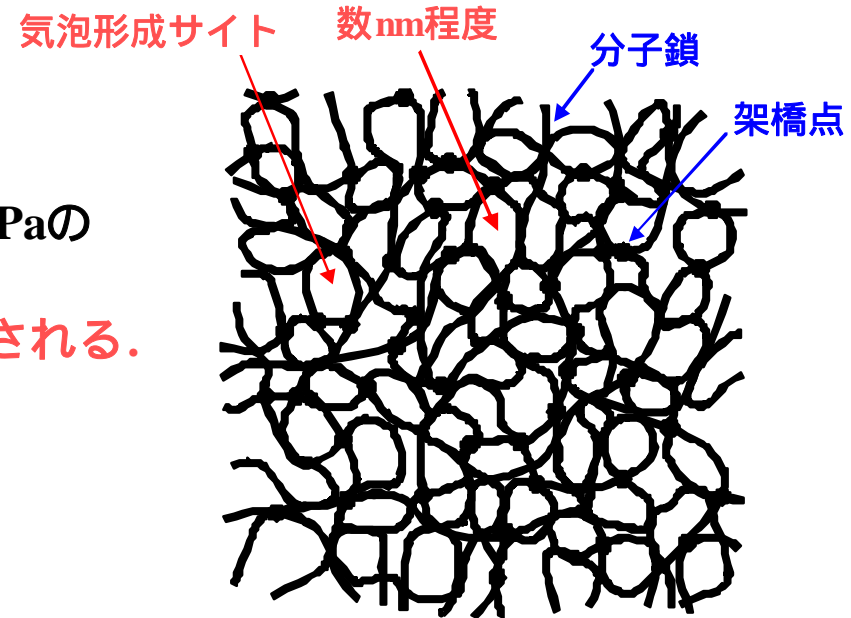
均一な構造では，圧力0.6MPaの  
気泡形成を説明できない！  
不均一構造の存在が示唆される。

均一な網目構造のイメージ

$$a_{cr} = \frac{\gamma}{p}$$

$$\gamma = 25 \times 10^{-3} \text{ N/m}$$

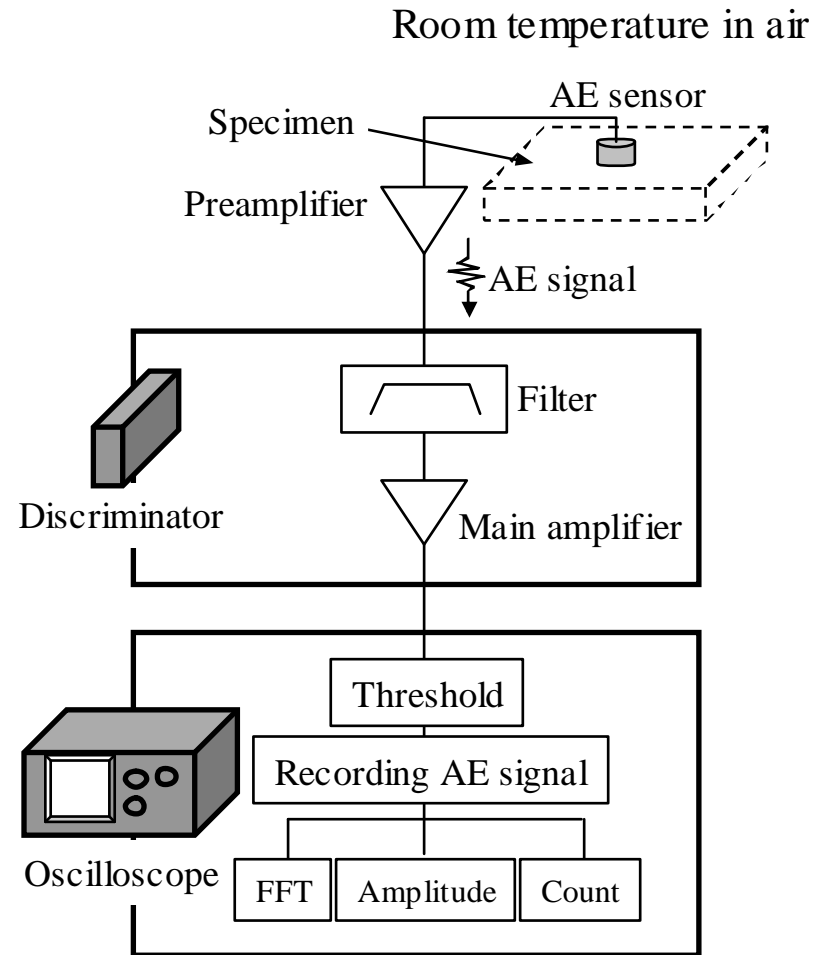
- ・ 室温 (20 ~ 25 °C) ・ 大気中において , 引張試験および静き裂進展試験を実施し , 発生するAEを計測 .
- ・ 水素曝露した試験片では , 減圧後5 ~ 10分から室温 ・ 大気中において AE計測を開始 .

- ・ AE sensor (FUJI CERAMICS M204A)  
Resonance type AE ··· 200kHz
- ・ Preamplifier (FUJI CERAMICS A1002)  
Gain ··· 55dB
- ・ Discriminator  
Frequency property ··· 1kHz ~ 2MHz (-3dB)  
Filter  
H.P.F ··· 100kHz  
L.P.F ··· THRU  
GAIN ··· 30dB
- ・ Oscilloscope  
Threshold ··· 400mV  
Dead time ··· 1 sec

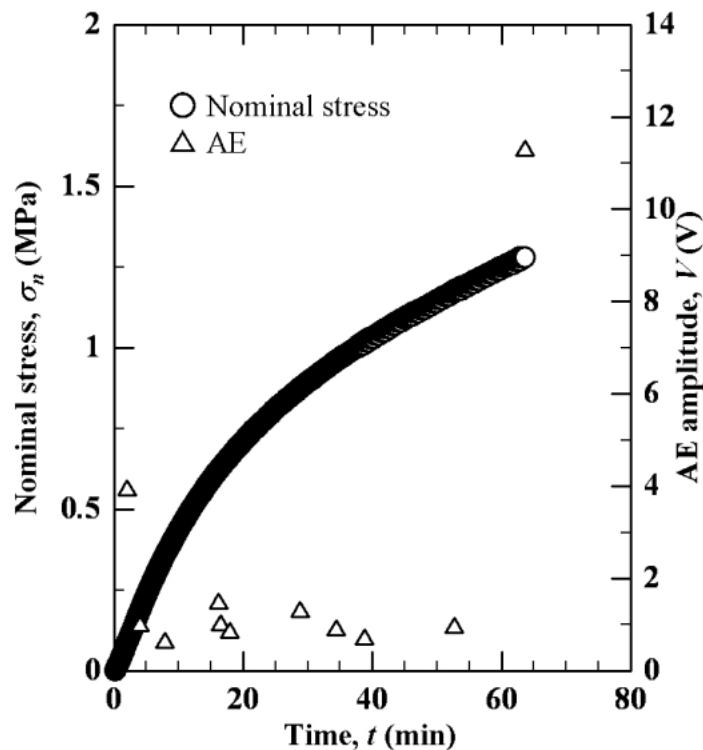
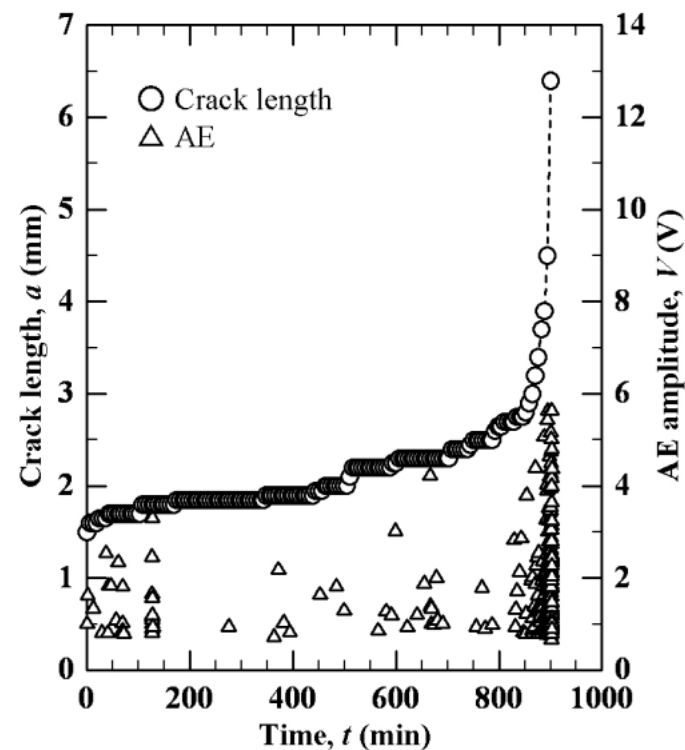
- As preliminary tests, tensile test and static crack growth test were conducted.
- AE signals were detected at crack growth test, whereas these were hardly detected at tensile test.

This result implies that the AE signals were mainly generated during fracture process of chain molecules, not deformation process.

Tensile test

Static crack growth test

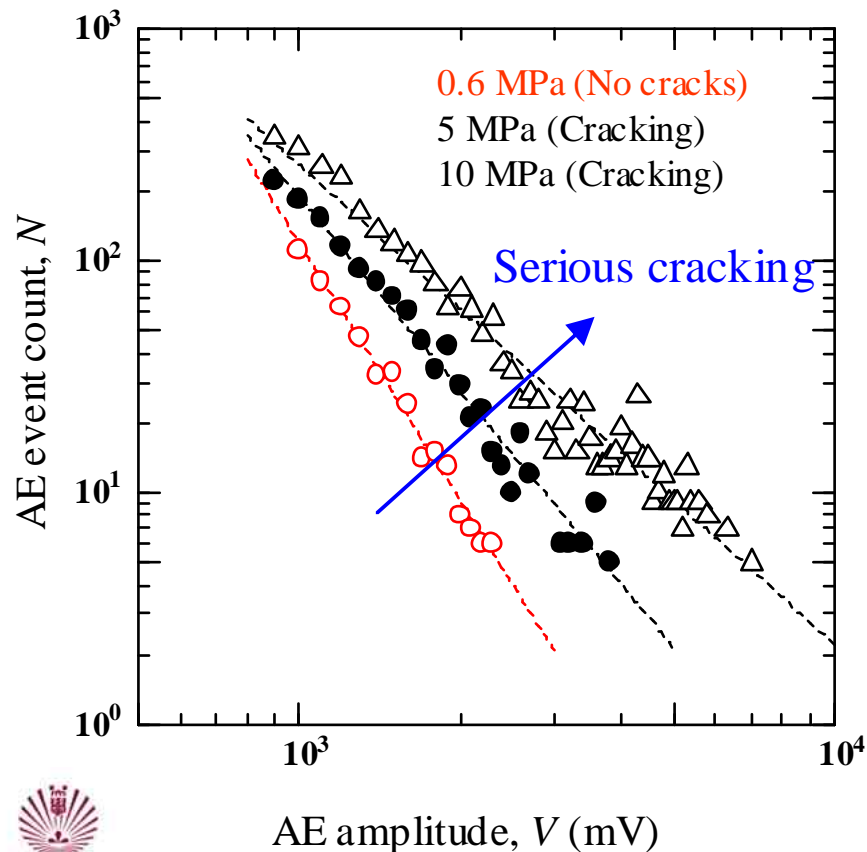
- AE event counts and amplitude increased with an increase in hydrogen pressure.
- In spite of the specimen exposed to 0.6 MPa hydrogen gas where no cracks initiate, AE signals were detected.

Nanoscale fracture occurs although no cracks are observed by optical microscopy.  
This result implies sub-micrometer-size bubbles initiate although no cracks initiate.

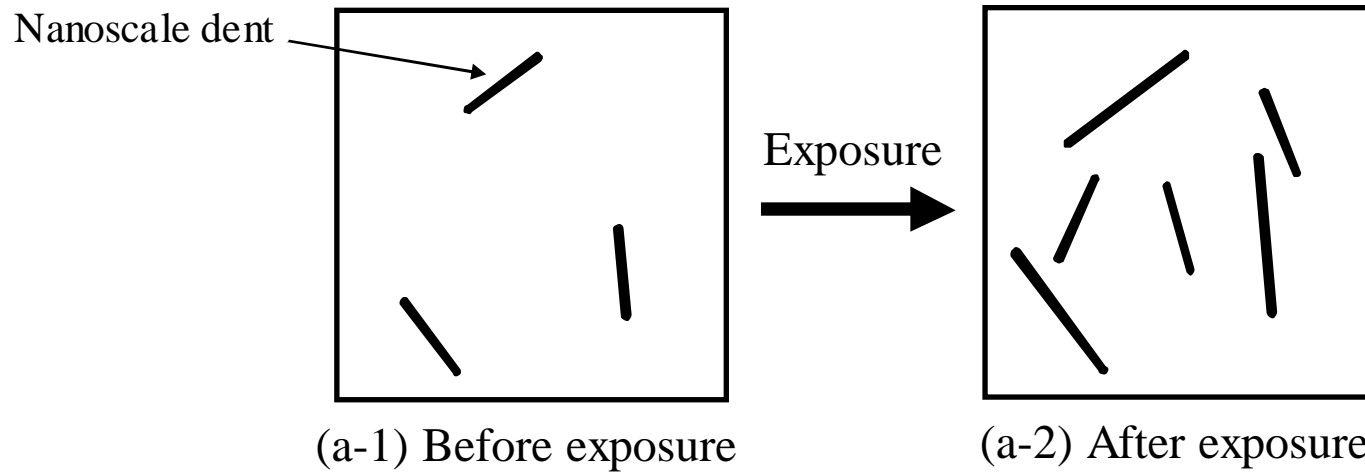
(a) AFM image

(b) Real structure

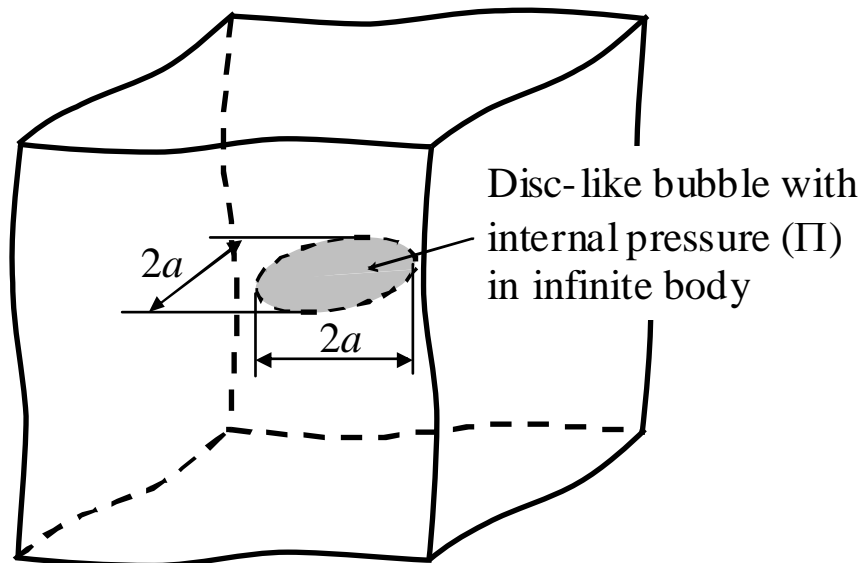
$$T = f(p, a) \geq \Gamma_F$$

$T$  : Tearing energy of bubble

$\Gamma_F$  : Fracture energy

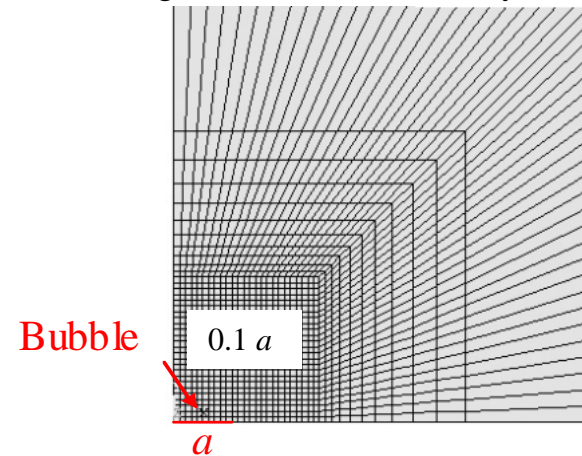
Meshing pattern near bubble tip

**Total energy method was employed.**

Eight-node element (axisymmetric)
